NASA CR-515

## INDUCTION PROCESSED SEPARABLE TUBULAR BRAZED CONNECTORS

*by V. Hunt*

*Prepared by*  
AEROJET-GENERAL CORPORATION  
Sacramento, Calif.  
*for Lewis Research Center*

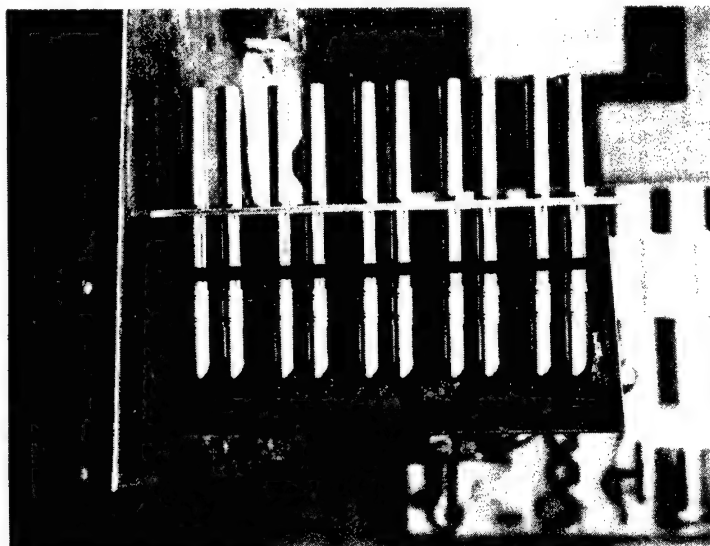
FIGURE 9

An end view of the tube-locating fixture which was used to qualify the special plier type brazing tools. The braze tool access area simulated the M-1 torus to thrust chamber area.

A front view of the tube locating fixture holding the tube spacing the same as on the M-1 torus to thrust chamber transition joints prior to brazing.

Multiple Tube Holding Fixture

Two views of the multiple tube holding fixture used to qualify the special braze plier-type tools is shown in Figure 9. Accessibility to the joints with the braze tool simulates the condition of the M-1 thrust chamber-to-torus transition joint, including the tube spacing and the clearance between the tubes and thrust chamber. The tubes are located in pairs on 1.134-in. centers. The spacing between the pairs is 1.71-in. on centers and the outside tube diameter is 0.760-in.

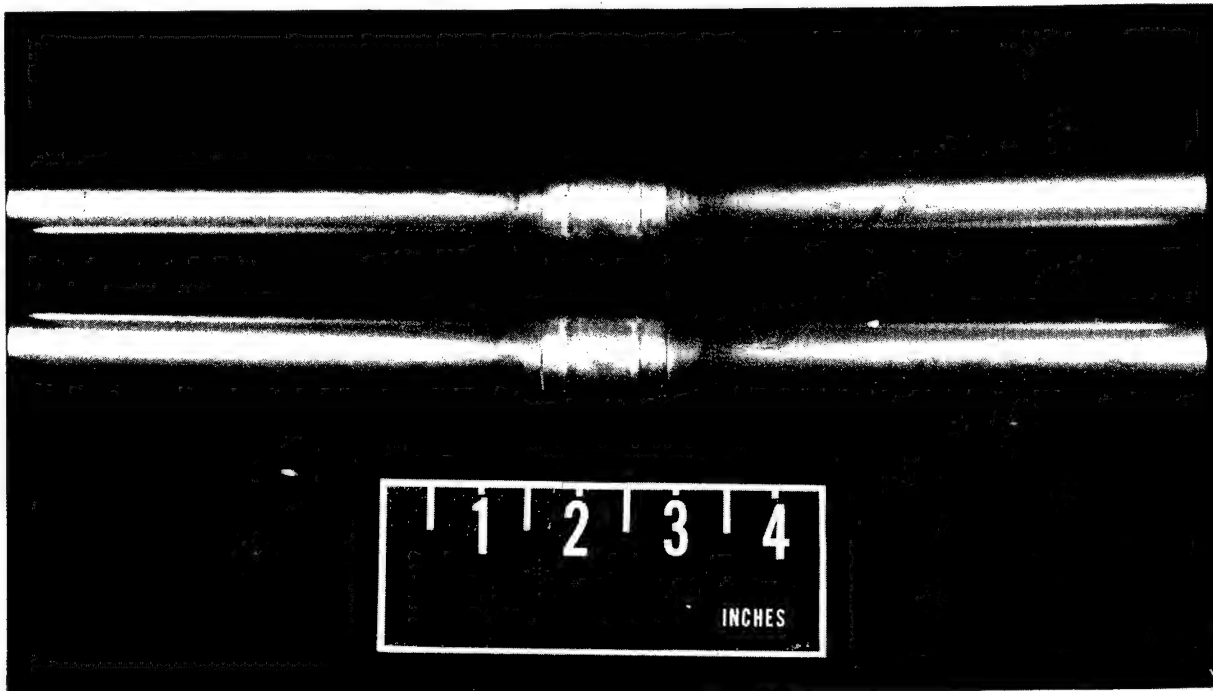
FIGURE 20

Two typical brazed specimens prepared for tensile testing.

The same two specimens after tensile testing at room temperature. Failures occurred at 7160 and 7200 pounds in the tubes.

Connector Brazed Tensile Specimens

The two brazed joints shown in the upper view of Figure 20 were exposed to tensile tests at room temperature. Failures occurred in the tubes at 7160 lb and 7200 lb loads or approximately 97,000 psi ultimate tensile strength. The failure occurred well away from the brazed sleeve, as shown in the lower view of Figure 20.
